# What we can learn from the Dutch: Rebuilding Kerala post 2018 floods

Venu Rajamony and Rakesh N.M.

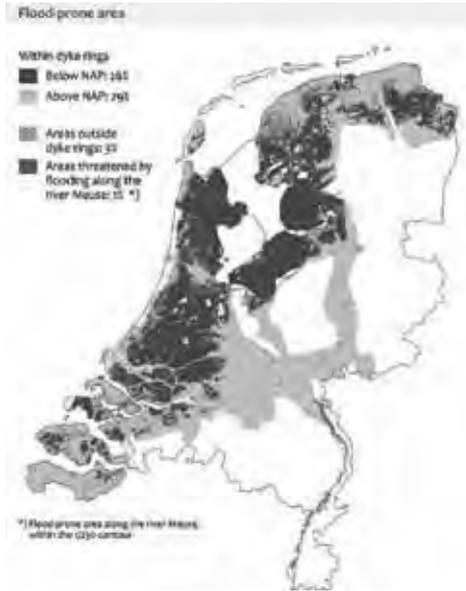
Figure 1. Flood prone landscapes of the Netherlands in NAP<sup>1</sup> scale (image source: PBL Netherlands Environmental Assessment Agency / Rijkswaterstaat-Waterdienst [2010b], PBL website, <http://www.pbl.nl>)

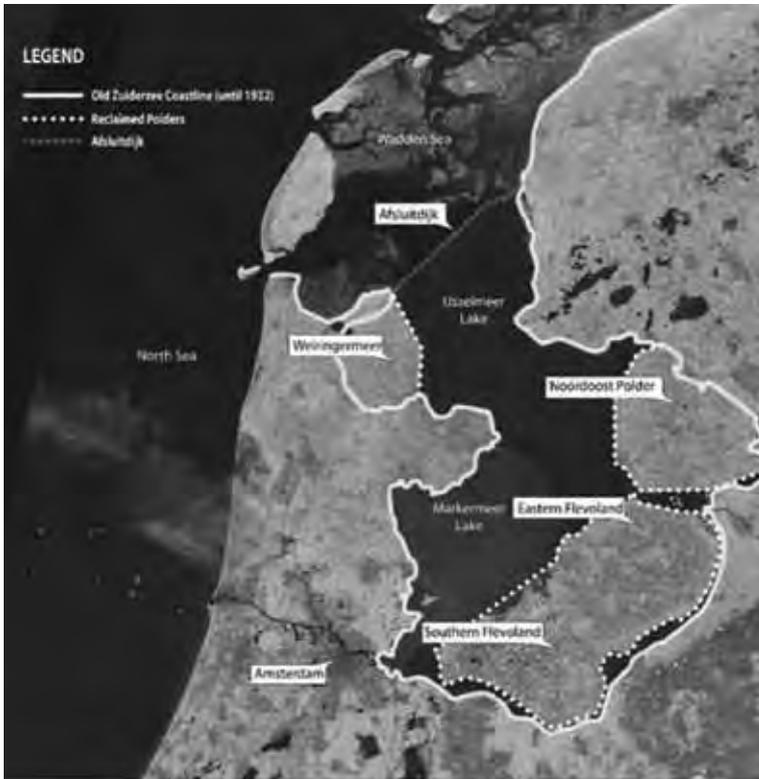
Figure 7. The Afsluitdijk and the reclaimed polders (Image source: Author)

The Afsluitdijk was built over a span of five years by an army of men. A large part of the project was handcrafted. The base of the dam was constructed with basalt rocks and fabric woven from willow branches. Clay boulders dredged from the bottom of the Zuiderzee were set one on top of the other to build the base of the dam. The surface of the dam was further planted with grass to guard it from erosion. A motorway was constructed over the dam and 25 sluices built into it to allow for water discharge and ship navigation.

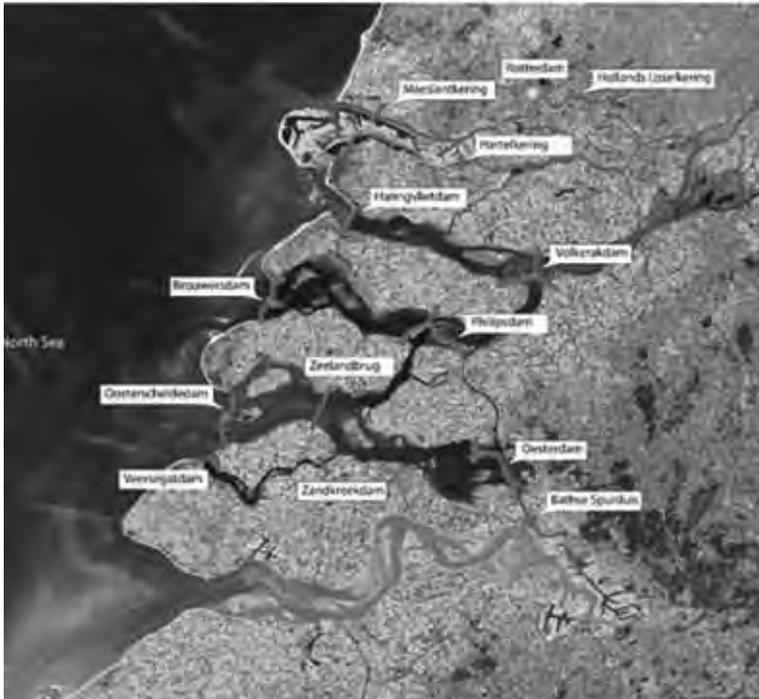
Figure 12. Map of the south-west delta region of the Netherlands with its series of construction projects as part of the Delta Works Project (Image source: US Geological Survey, processed by Pierre Markuse)

The last three of the recommendations were implemented with a series of construction projects. They were the Zandkreek dam (completed in 1960), Veerse gat dam (1961), Volkerakdam (1967),

Haringleit dam (1971), the Brouwerhavense Gat (1971), Grevelingen dam (1972) and the Oosterscheldekering (1986). The construction of these dams reduced the vulnerable coast length of the south-west delta by almost 1,000 km. The technological provisions within these dams further ensured that salt water intrusion to inland waterways was prevented. They also provided better connectivity to otherwise detached islands within the Delta.

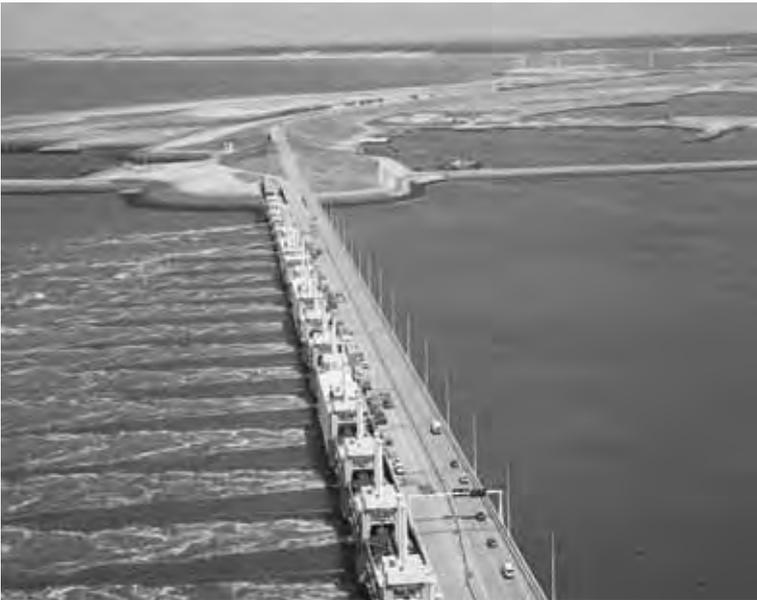
*Figure 13. The 3 km long storm surge barrier Oosterscheldekering  
(Image source: <https://beeldbank.rws.nl>, Rijkswaterstaat)*

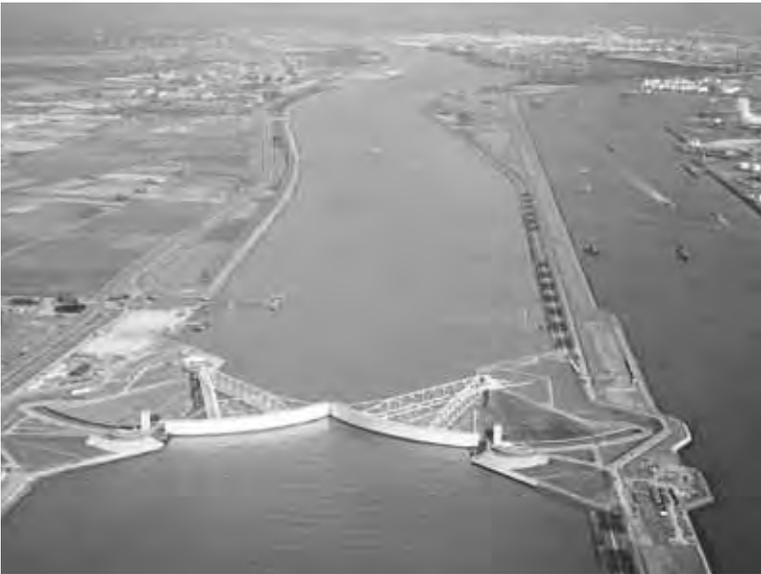
Figure 14. Closed sea gate with the port of Rotterdam visible on the top of the picture.  
(Image source: <https://beeldbank.rws.nl>, Rijkswaterstaat)

Maeslantkering is a giant sea gate located few kilometres away from the port of Rotterdam, one of the busiest ports in the world and the largest in Europe. It allows for the navigation of container ships and goods through the river canal while defending the port from threats of the sea.

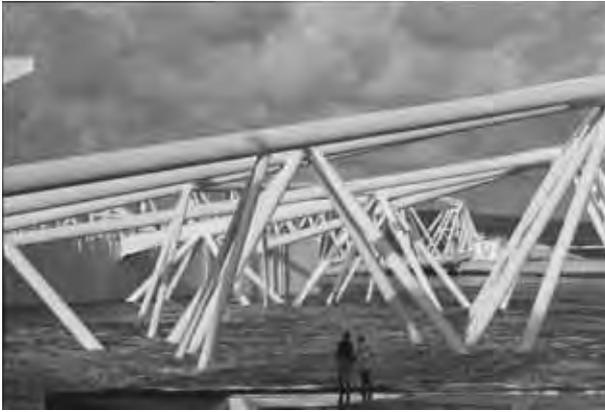
Figure 15. The size of the immersed sea gate with reference to human scale  
(Image source: <https://beeldbank.rws.nl>, Rijkswaterstaat)

The sea gate consists of two giant steel tubular arms, each the size of the Eiffel Tower, that rests on the banks of the river canal. These arms are 210 m wide, 22 m high and 15 m deep each. During a sea level rise, the arms of the gate are closed and locked. The tubes get filled with water, submerging the gate into a concrete bed, which erects a giant steel wall against the sea. The pressure of the sea on the gate gets transferred to the largest (10 m diameter) ball joint in the world, on the bank of the river. It takes 2 hours' time to erect this sea wall.

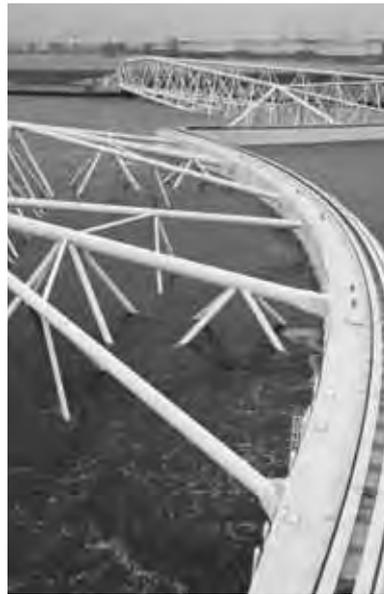
Figure 16. The tubes of the gate are filled with water to immerse the gates into the river canal, erecting the sea wall (Image source: <https://beeldbank.rws.nl>, Rijkswaterstaat)

The entire system is automated, as the computer monitors sea levels every hour. The computer system automatically decides when to open and close the gates. In order to reopen the gates, water in the tubes need to be emptied out. These gates are equipped with many motors to empty the water out. These motors are connected to the power grid of the country, with another backup grid and a generator. Failure to reopen the gate can pose even more threat, as blockage of water discharges from the rivers of Rhine and Meuse will flood the city of Rotterdam even faster than the North Sea. Maeslantkering is a monumental achievement of engineering. During its construction in 1997, it was an unprecedented way to safeguard the delta from the effects of sea storm surges or sea level rises, without compromising on transport and economic activities of the busy port and safety of its citizens.

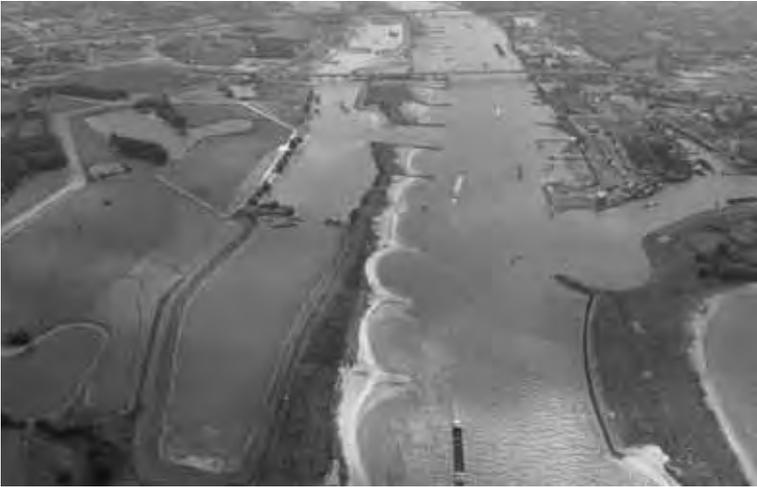
Figure 18. Creating room for the river by cutting a new channel at Nijmegen  
(Image source: <https://beeldbank.rws.nl>, Rijkswaterstaat, Room for the River)

✦ **Room for Waal in Nijmegen:** Nijmegen is a town that is located on the banks of the River Waal. The river takes a sharp turn here and narrows itself to form a bottleneck. This bottleneck has caused floods in the town or put pressures on the dikes along the river during the high waters. After extensive public debate, it was decided to shift the dikes 350 m inland. Thus, there is enough room to construct a secondary channel for the river. This channel provides additional capacity for water drainage during high waters.

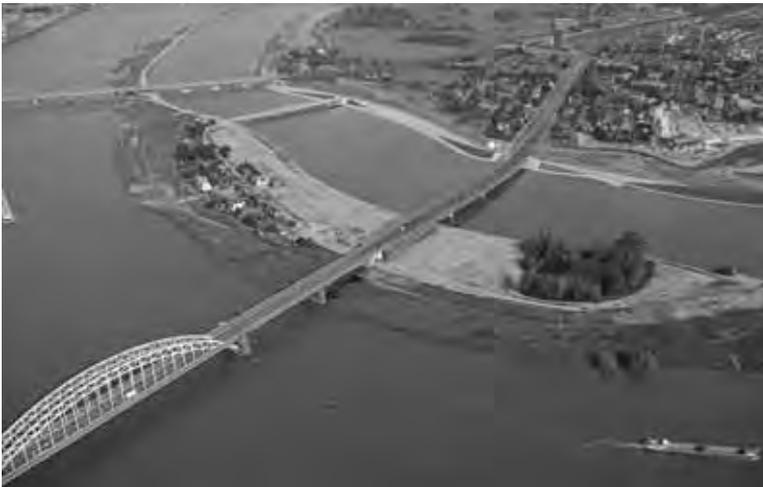
Figure 19. Nijmegen with the new river channel  
(Image source: <https://beeldbank.rws.nl>, Rijkswaterstaat, Room for the River)

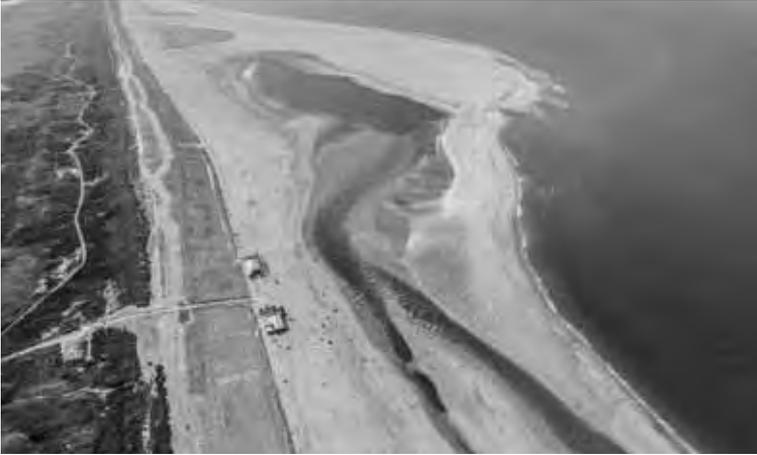
*Figure 1. Bird's-eye view of the Sand Motor  
(Image source: <https://beeldbank.rws.nl>, Rijkswaterstaat)*

was dredged 10 km off the coast and deposited along the shore. The peninsula was made up of 20 million m<sup>3</sup> of sand, in a short span of 8 months in 2011.

The project shows that the sandbank could stimulate the currents to transport sand through erosion and sedimentation to the weak spots along the coast and reinforce them. The process created an additional 35 hectares of beach which is today used for recreation such as windsurfing and kitesurfing. The constant

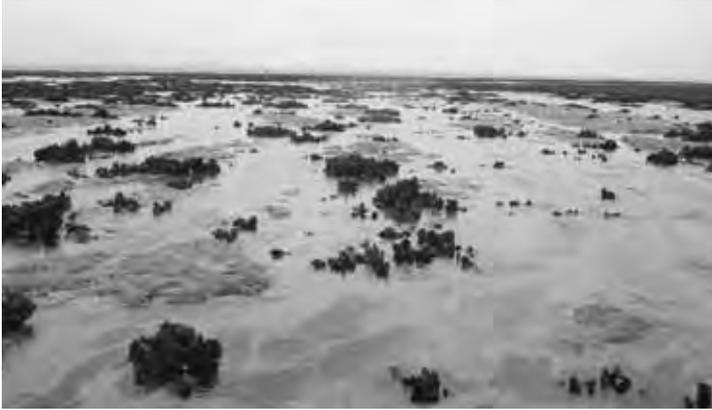
*Figure 4. The oyster reef structure at Oosterschelde  
(Image source: <https://beeldbank.rws.nl>, Rijkswaterstaat)*

A pilot project was conducted in 2007 to study the effects of natural reefs to prevent the erosion. In order to build a natural reef, dead oyster shells were stowed in steel wire gabions. Later, oyster larvae that needed a hard substrate on which to grow, attached themselves to the shells to build up the oyster reef structure. The steel wire gabion rusted away from the reef structure once the oysters started to colonise. Moreover, the reefs were constantly renewing and growing themselves by attracting new larvae. These reef structures could dissipate the waves in shallow water and increase the sedimentation within the estuary. The project showed that these natural reefs had the capability to prevent erosion and thus preserve the tidal flats. With the success of these reefs, the same technique was used on a larger scale in 2010 in another two locations within the Eastern Scheldt to similar effect.

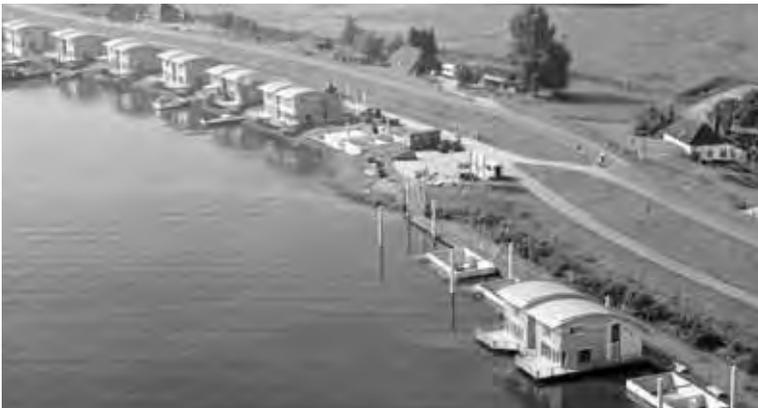
*Figure 5. The row of floating houses in Maasbommel  
(Image source: <https://beeldbank.rws.nl>, Rijkswaterstaat)*

When the water level rises, the house moves upward along the vertical pile. The house is fastened onto the pile to limit the motion of the house caused by water. The floating homes are lowered back to the normal height once the water level drops. The houses are made of lightweight timber, and the hollow concrete base at the bottom is waterproof with added aggregates. The water, sewage and electric connections of the houses are also flexibly attached, thus ensuring that they continue to work during high-water situations.

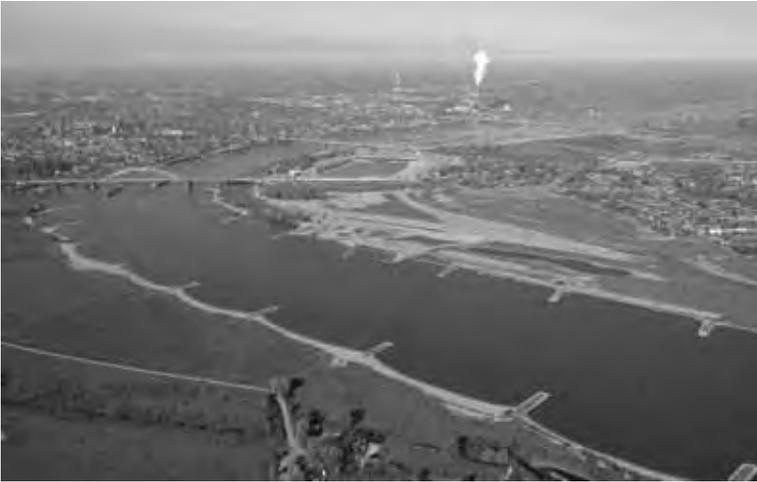
*Figure 10. New channel and formation of island in the River Waal  
(Image source: <https://beeldbank.rws.nl>, Rijkswaterstaat, Room for the River)*

Nijmegen is a town located on the banks of the River Waal. The river takes a sharp turn here and narrows itself to form a bottleneck. This bottleneck has caused floods in the town and put pressure on the dikes along the river during high waters. The national government decided that this bottleneck needed to be addressed and more room created for the river.

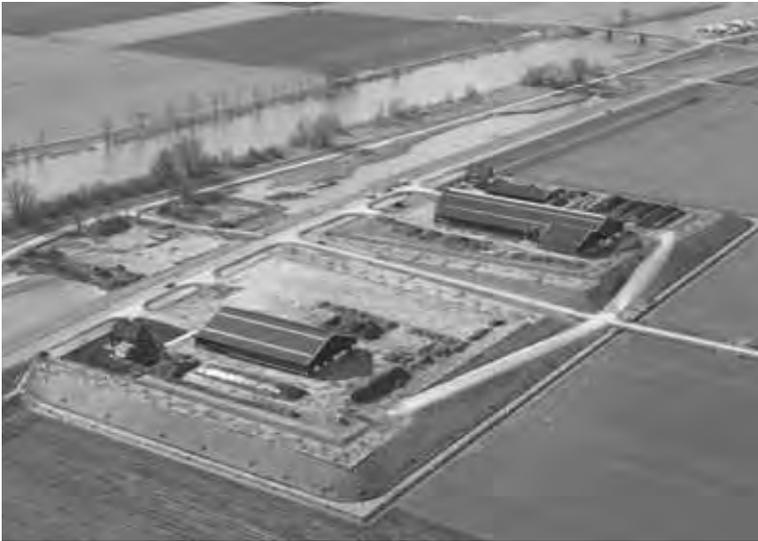
*Figure 13. The construction of terps on the flood plain landscape  
(Image source: <https://beeldbank.rws.nl>, Rijkswaterstaat, Room for the River)*

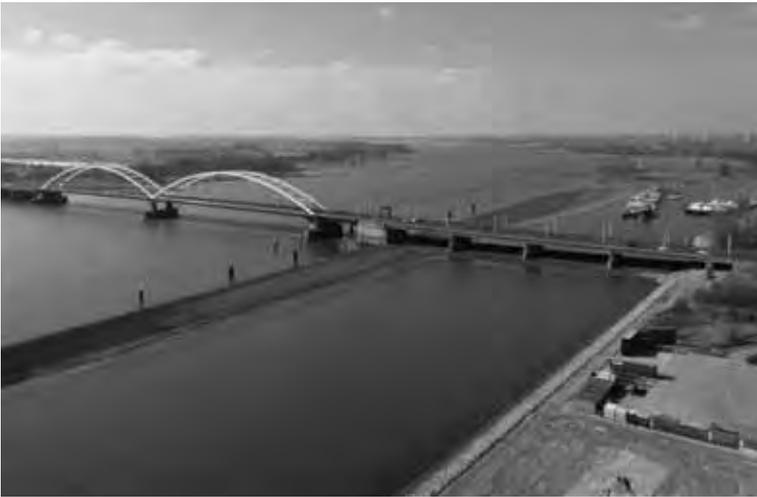
*Figure 16. The new channel excavated along the business area of Avelingen  
(Image source: <https://beeldbank.rws.nl>, Rijkswaterstaat, Room for the River)*

In order to give more space for the river to flow, a flood plain along the industrial zone was excavated in addition to the digging of a side channel. These measures on the river channel at Avelingen resulted in about a 10 cm drop in the water level at the town of Gorinchem.

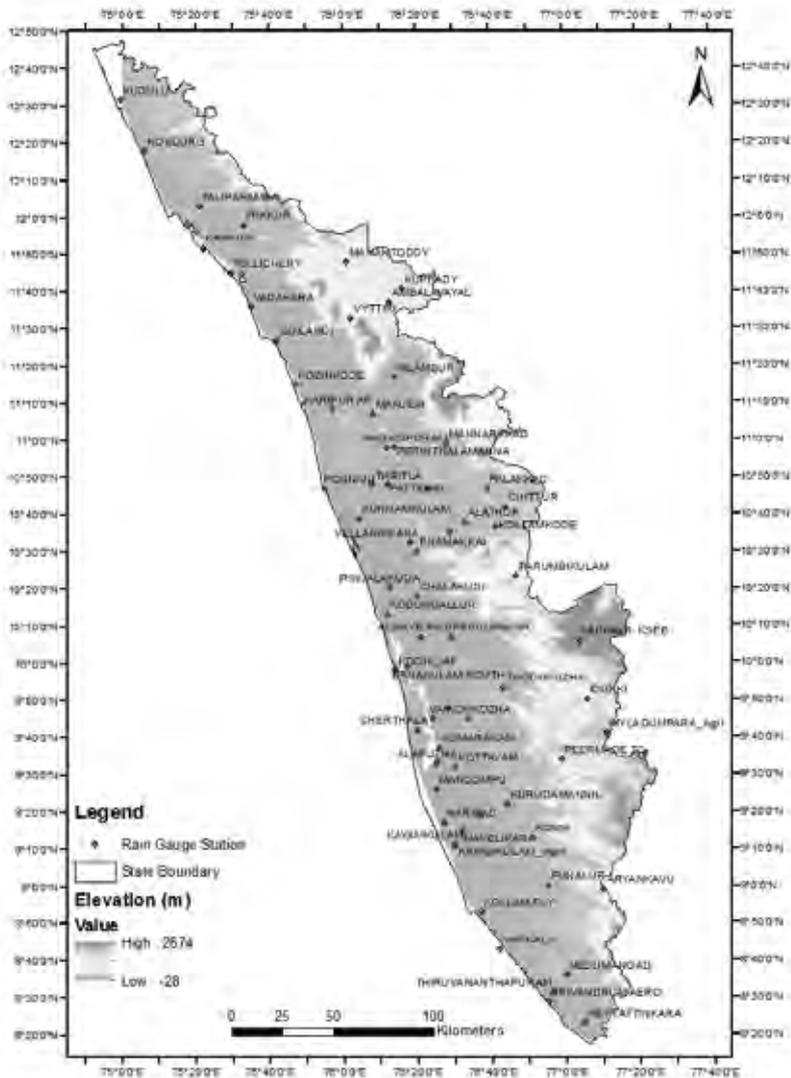
Fig.1: Rain gauge stations of Kerala used for rainfall analysis

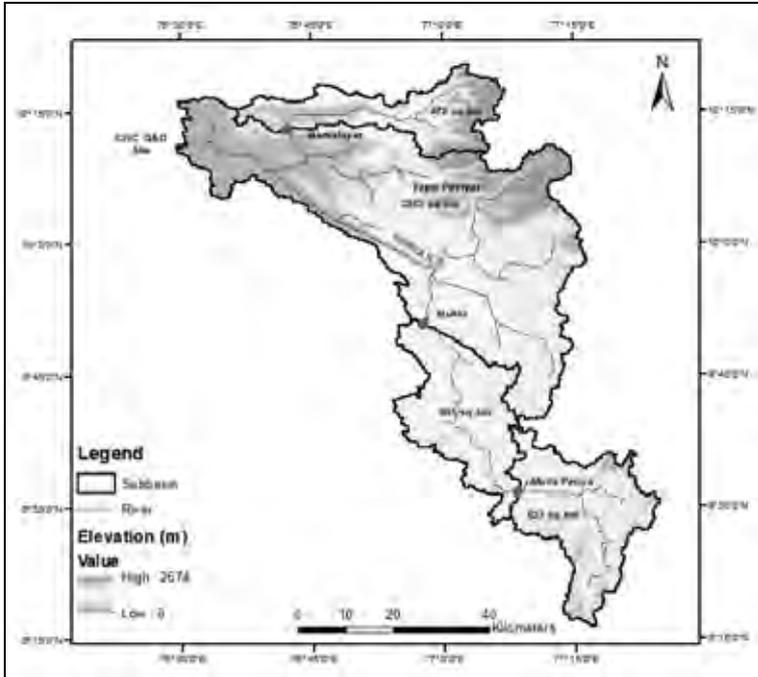
**Fig.2 Drainage area map of Periyar river up to Neeleshwaram G&D Site**

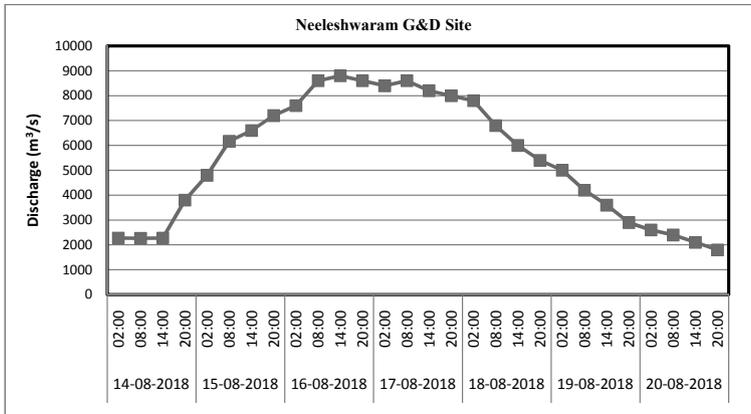
**Fig.3: Discharge data of Periyar river at Neeleshwaram G&D site**

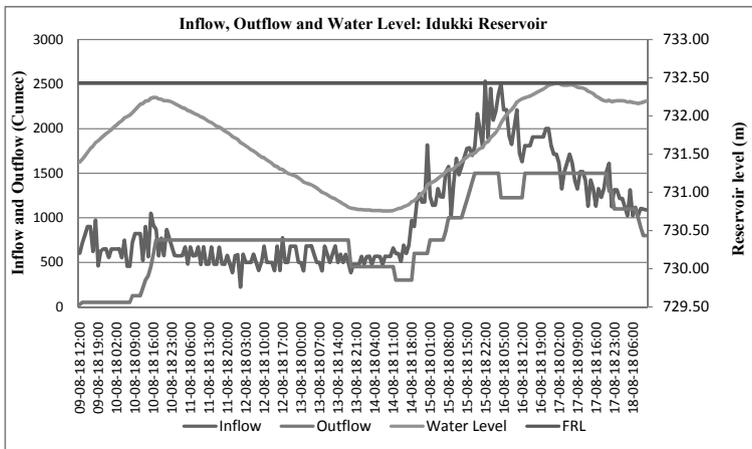
**Fig.4: Inflow, outflow and water level at Idukki reservoir**

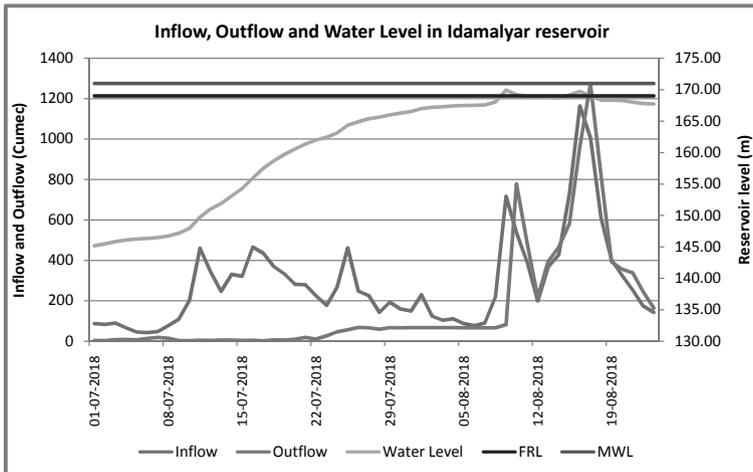
**Fig.5: Inflow, outflow and water level at Idamalayar reservoir**

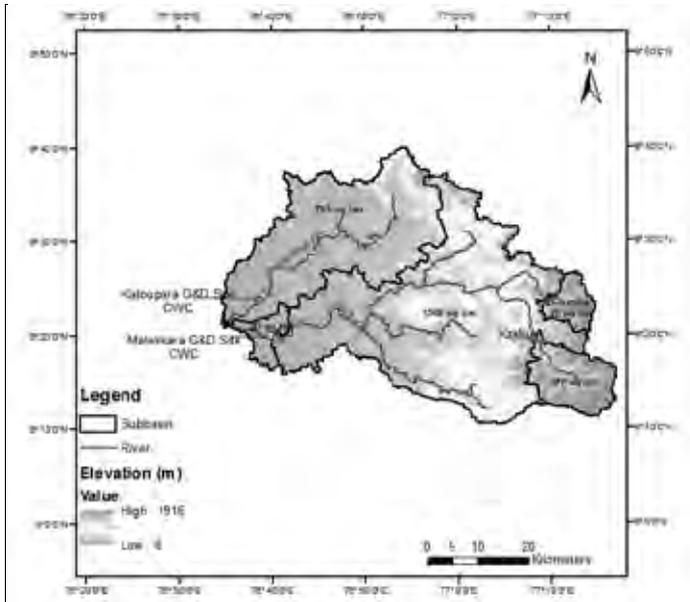
**Fig.6: Drainage area map of Pamba and Manimala rivers**

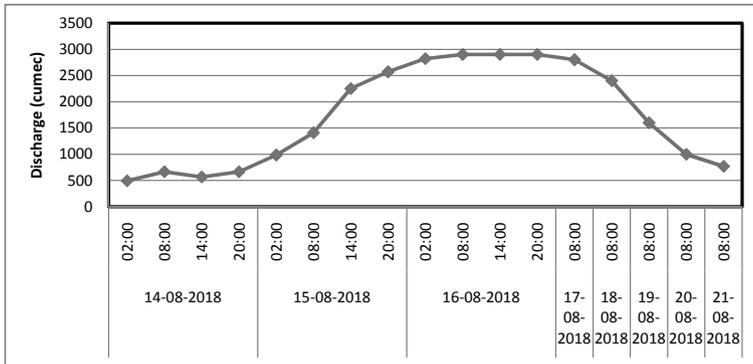
**Fig.7: Discharge data of Malakkara G&D site on Pamba River**

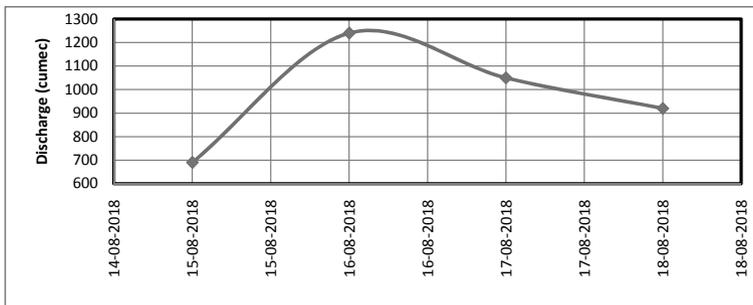
**Fig.8: Discharge data of Kalloppara G&D site on Manimala River**

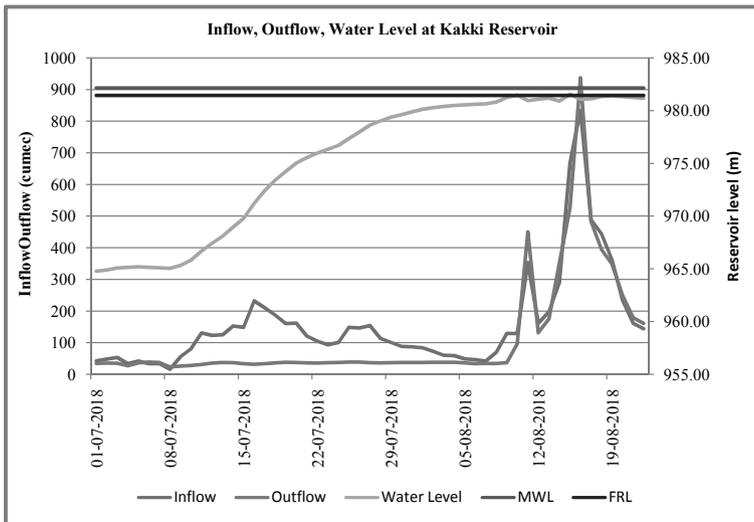
**Fig.9: Inflow, Outflow and Water Level attained at Kakki reservoir**

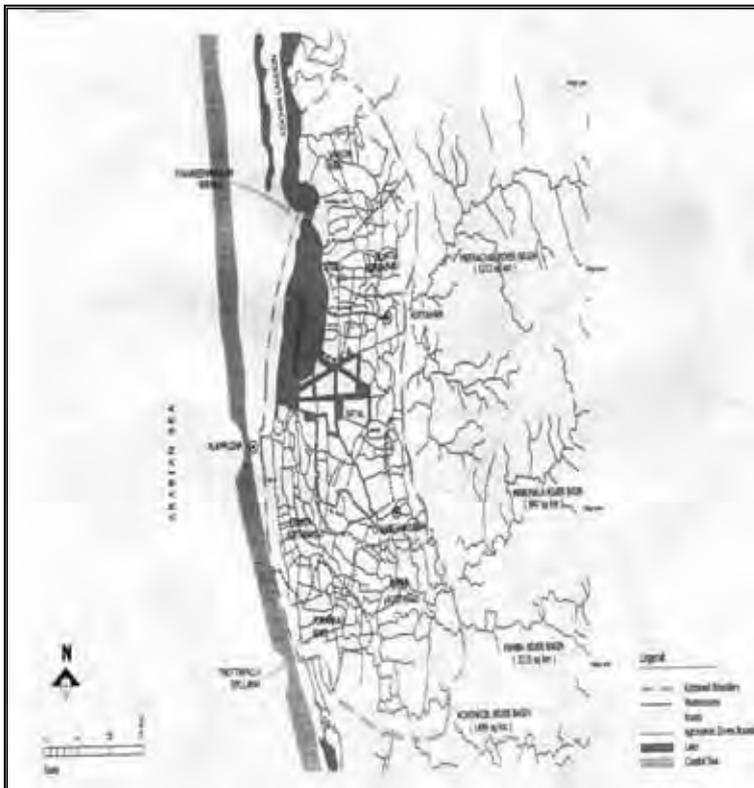
Fig.10: Index map of Vembanad Lake

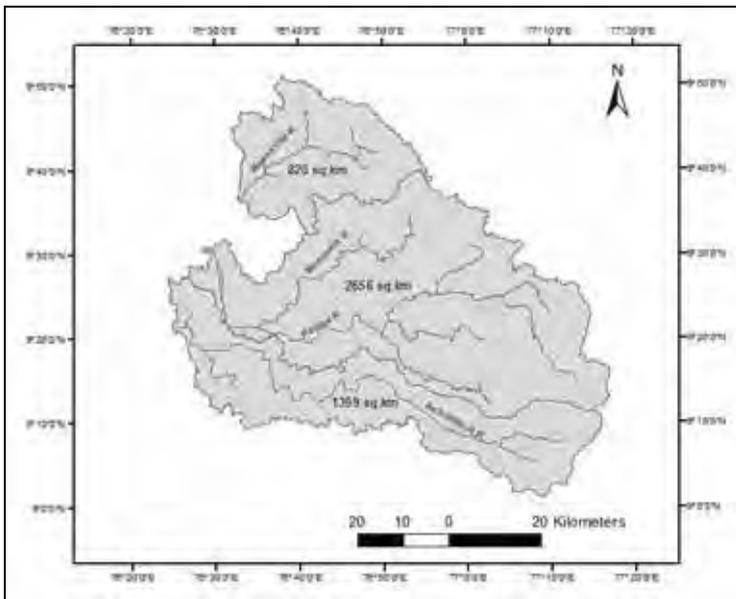
**Fig.11: catchment area map of Pamba, Manimala, Achenkoil and Meenachi river systems**

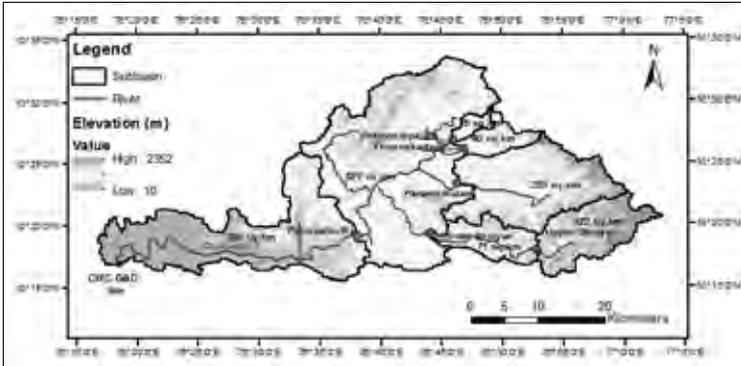
**Fig.12: Drainage area map of Chalakudy river up to Arangali G&D Site of CWC**

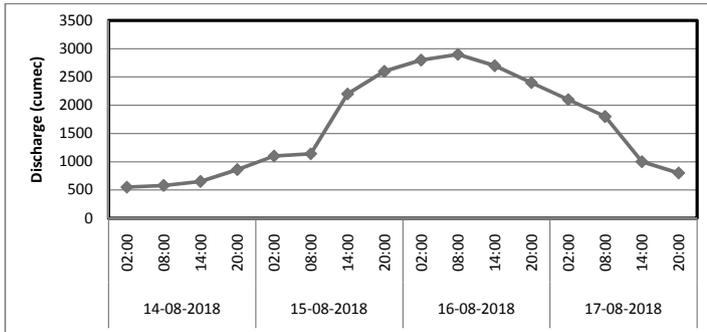
**Fig.13: Discharge data of Chalakudy river at Arangaly G&D site**

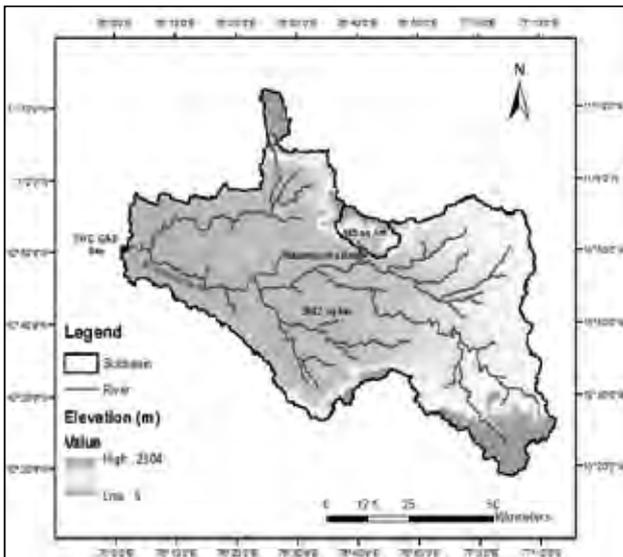
Fig.14: Drainage area map of Bharathapuzha up to Kumbidi G&D Site

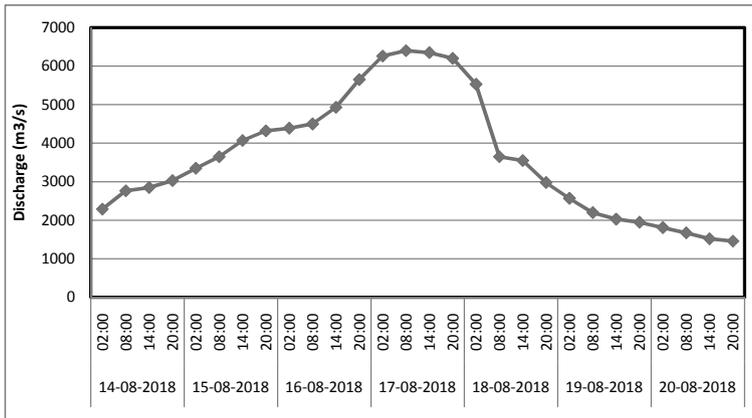
**Fig.15: Discharge data of Bharathapuzha River at Kumbidi G&D site**

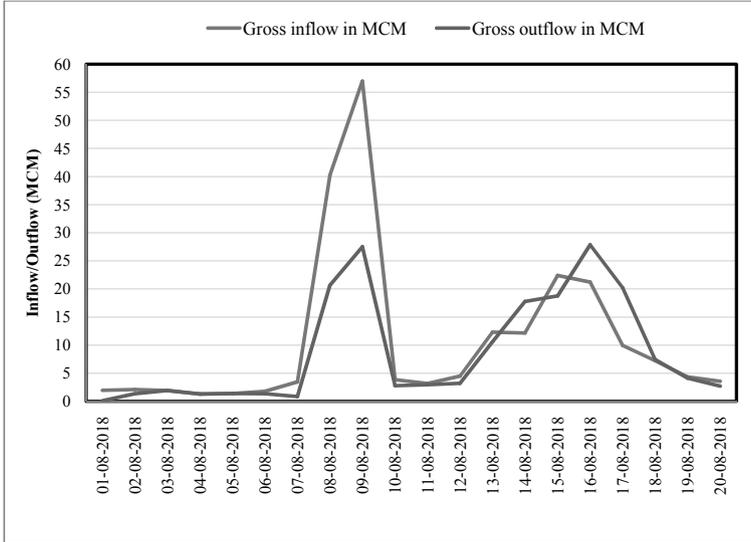
**Fig.16: Inflow and outflow from Malapuzha reservoir**

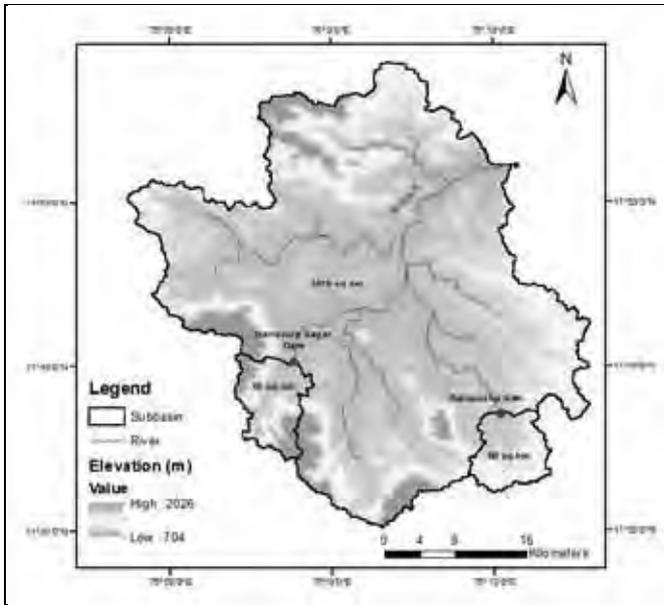
**Fig.17: Drainage area map of Kabini river up to Muthankera G&D Site**

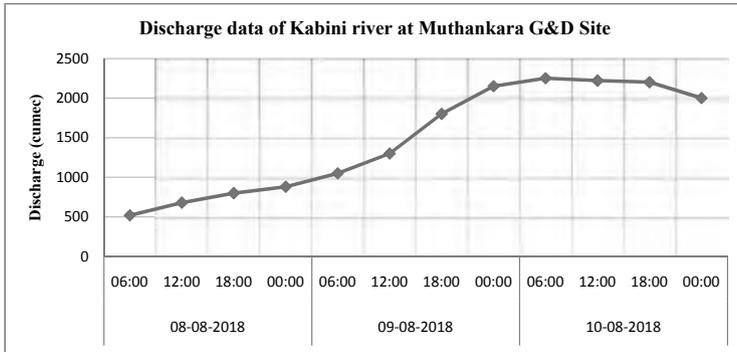
**Fig.18: Discharge data of Kabini River at Muthankara G&D site**

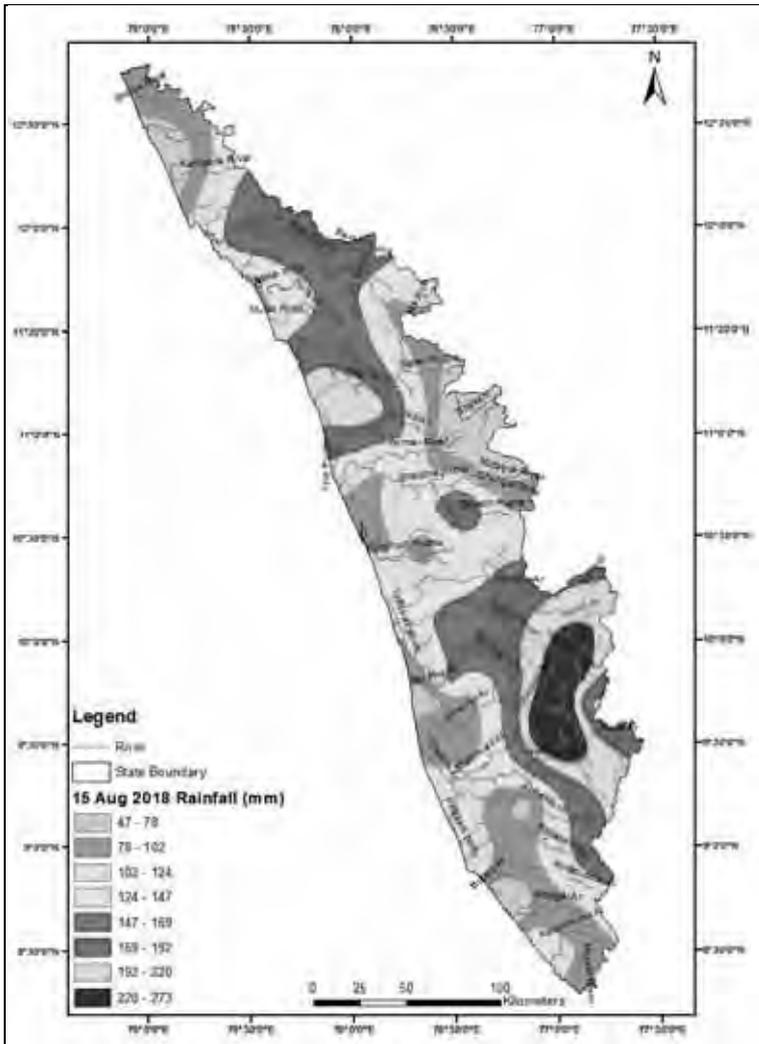
1 day rainfall of 15 August 2018

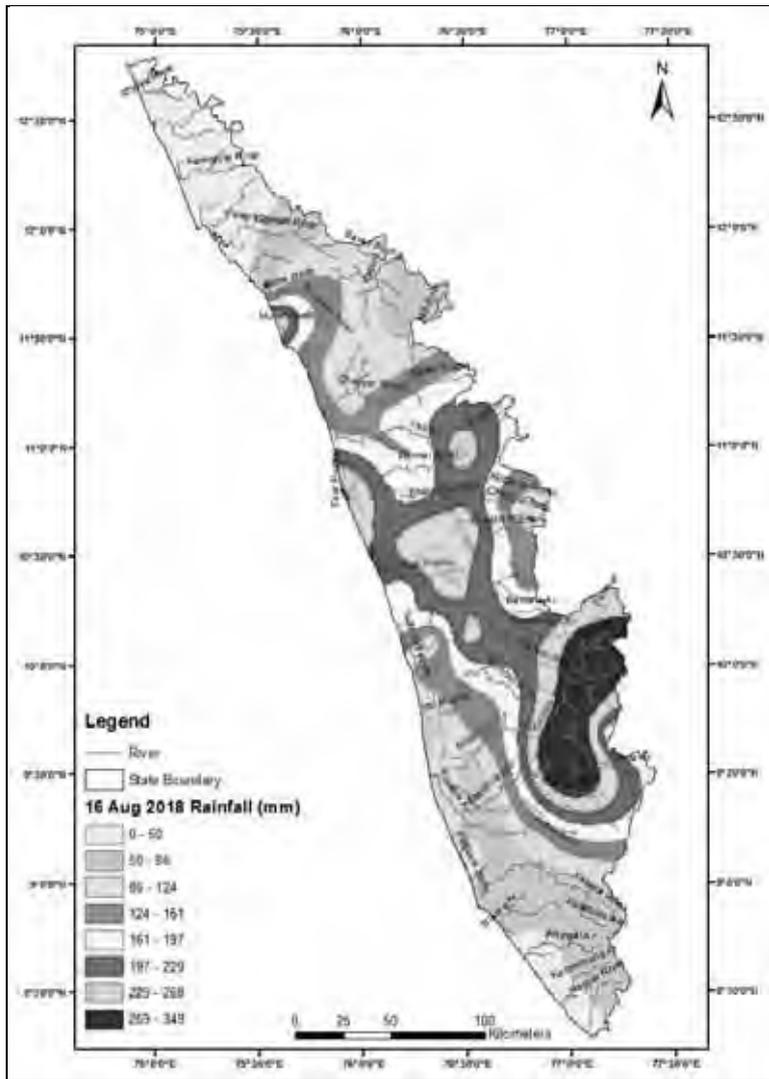
1 day rainfall of 16 August 2018

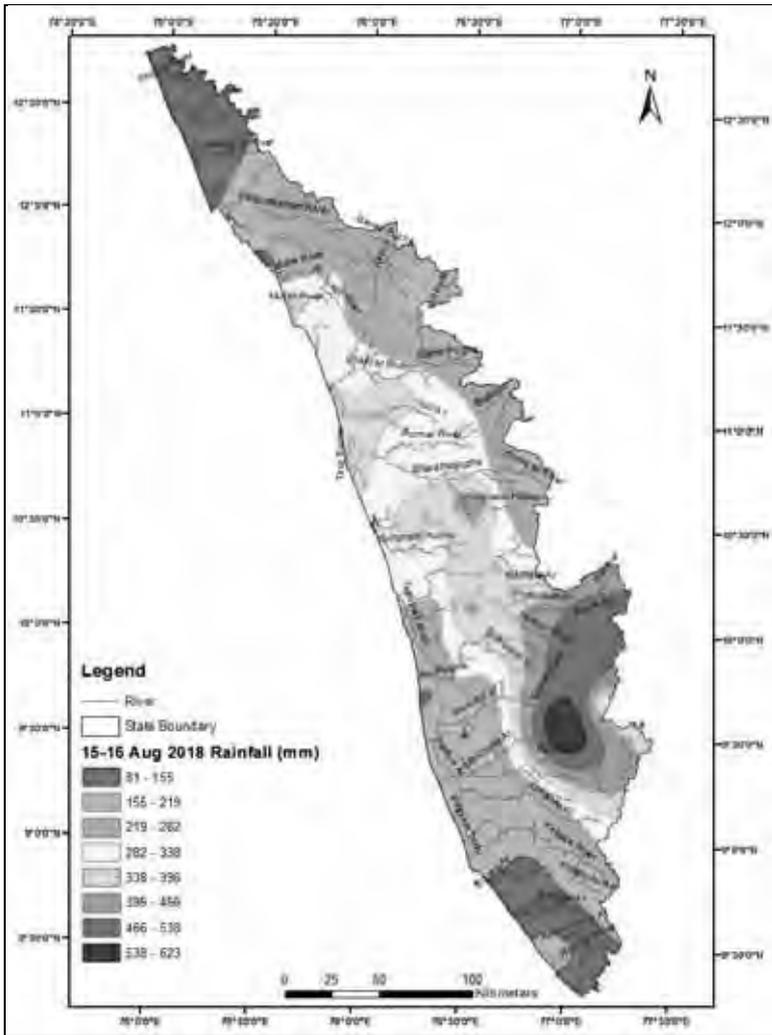
2 days cumulative rainfall of 15-16, August 2018

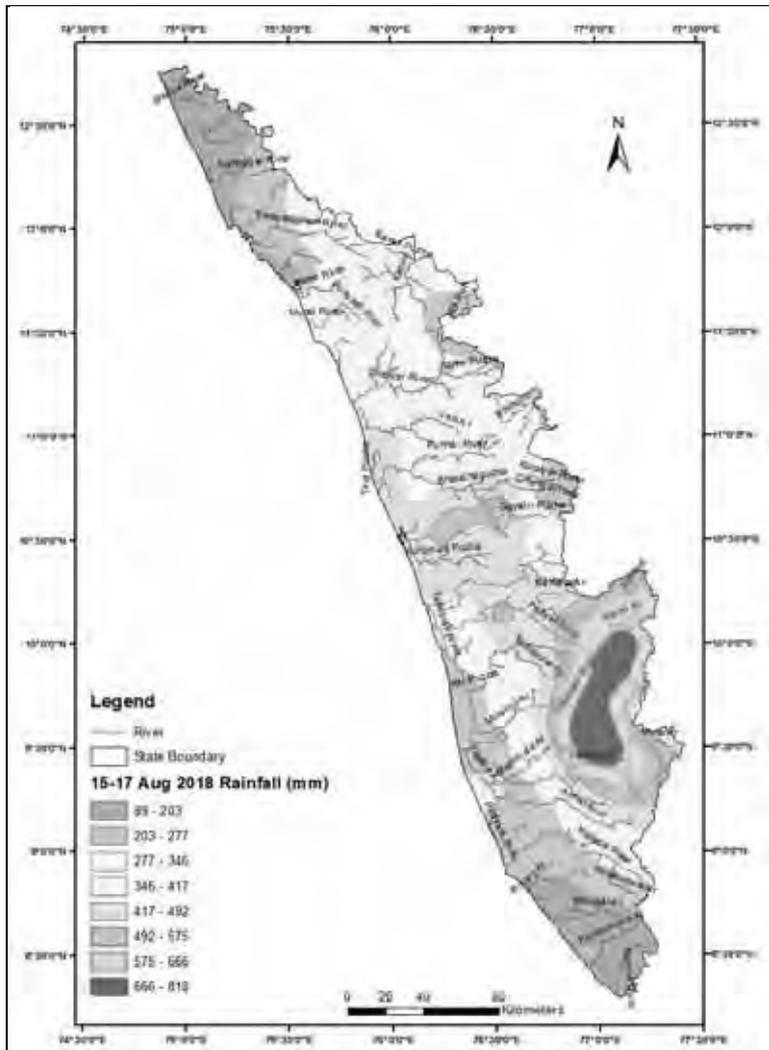
3 days cumulative rainfall of 15-17, August 2018
